Certified Appraisal of 1988 Gulfstream GIV-1159C
N01TB Serial Number 0001

Aircraft Appraisers International
AIRCRAFT APPRAISAL REPORT

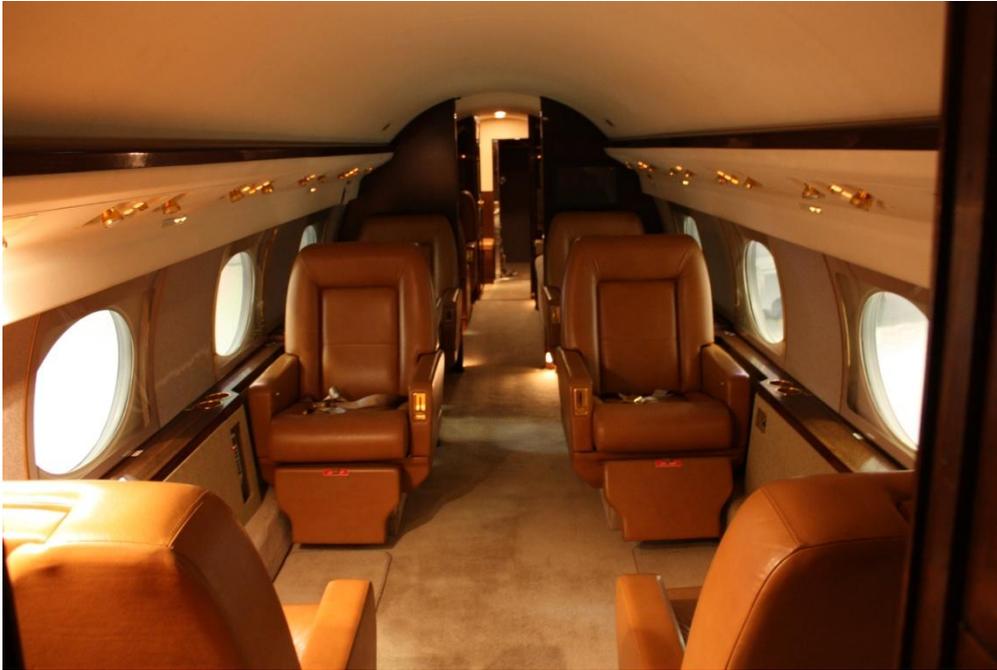
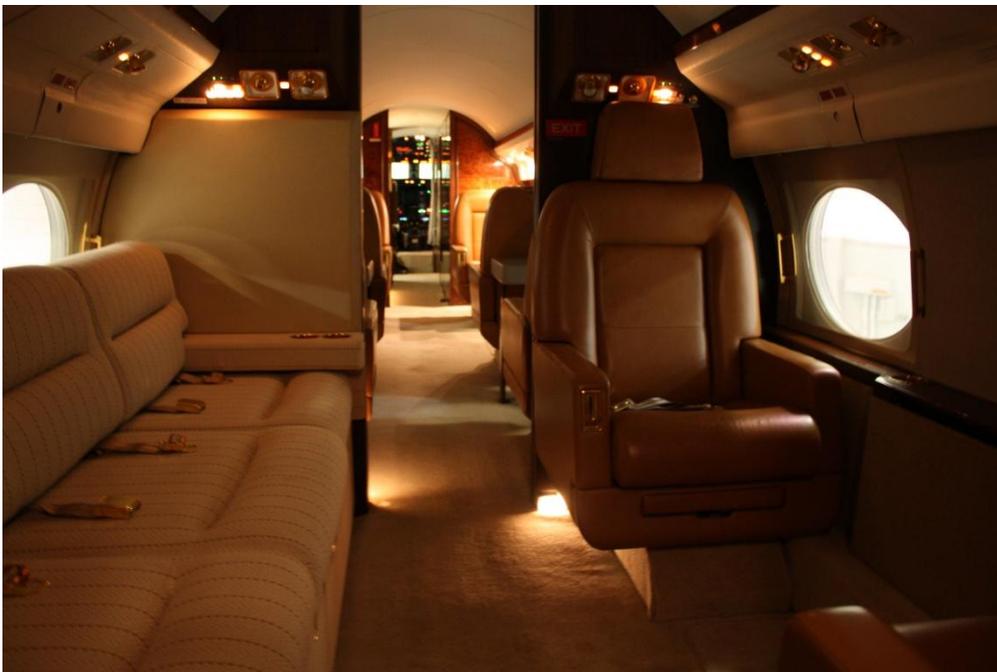
Interior Comments: In the front of the cabin, when walking in the front entry door, there is a galley finished with a polished high gloss dark veneer. The galley is on the left side of the aircraft or on your right as you walk farther into the cabin, and the forward crew lavatory is on the right side of the aircraft opposite the entry door. The galley cabinetry and forward lavatory are finished in a high gloss dark wood veneer. After the galley the aircraft interior consists of a forward four-place club seating arrangement covered in saddle tan leather. The club arrangement has folding side tables both left and right covered in a high gloss dark wood veneer. These club seats and the seats after the club seating are berth-able and were installed in 2004. Walking

towards the aft of the cabin the front club seating is followed by one seat on either side, which are berth-able and also with folding side tables covered in a high gloss dark veneer. Continuing towards the aft of the cabin the next section is accessed when you pass a divider with the matching veneer wood found in the forward part of the cabin. This aft section has a three-place berth-able divan on the left, opposite a two-place club seating arrangement in the saddle tan leather and with a wood veneer covered side table. All of the cabin and lavatory accessories are finished with gold plating.

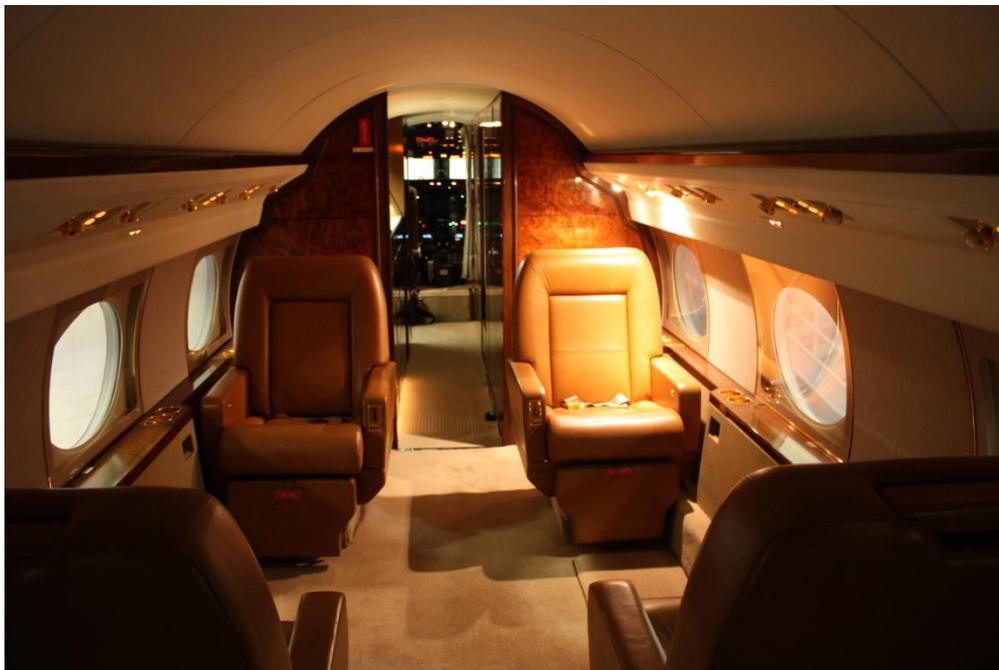
The cabin interior did have some defects. Most, but not all, were only noticeable on close scrutiny. These blemishes or defects include one chip in the wood veneer just inside the doorway on the left as you walk back and is located about 3/4 of the way down from the top of the cabinetry. Just aft of the cockpit on the upper right hand side the wood veneer has what appears to be a small area where a gouge in the veneer has been burnished or repaired. The folding tables show signs of normal use with light scratches that should be able to be buffed out. In the galley area it is common to find wear marks and this one is no exception with some light scratches located just forward of the forward lavatory midway from the top.

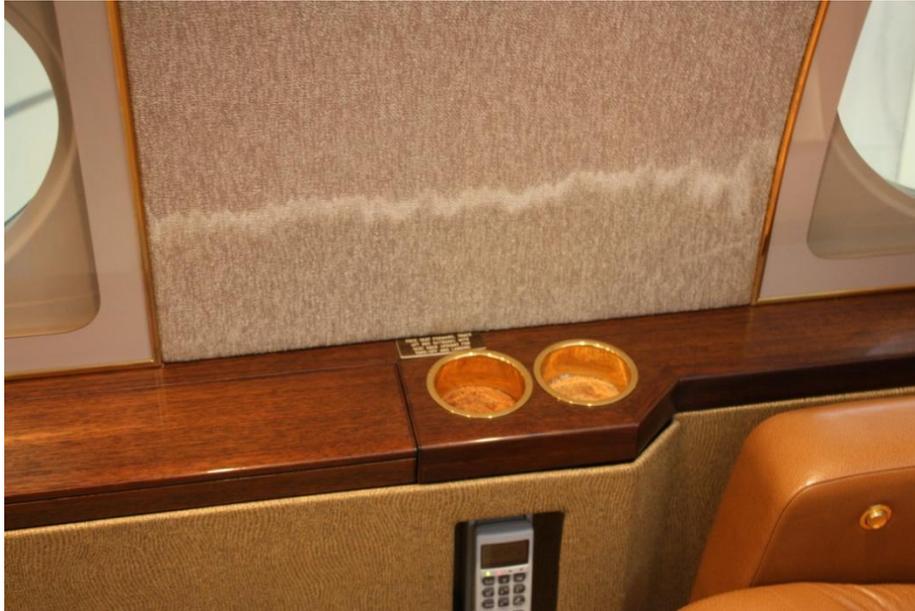
The window dado panels were in very good condition with one exception being on the right hand side of the aircraft between the third and fourth cabin windows. At that location the window dado panel was discolored (see picture).

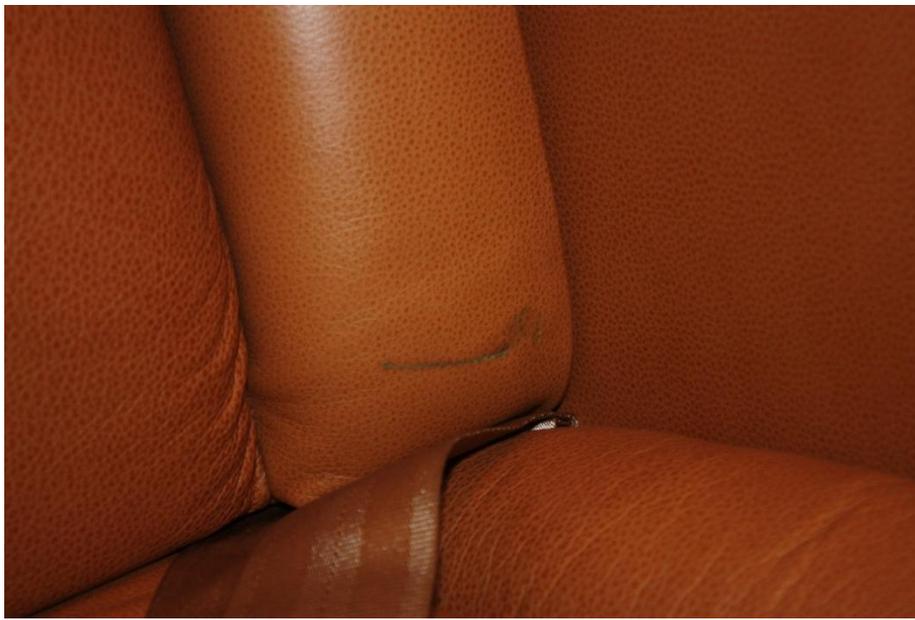
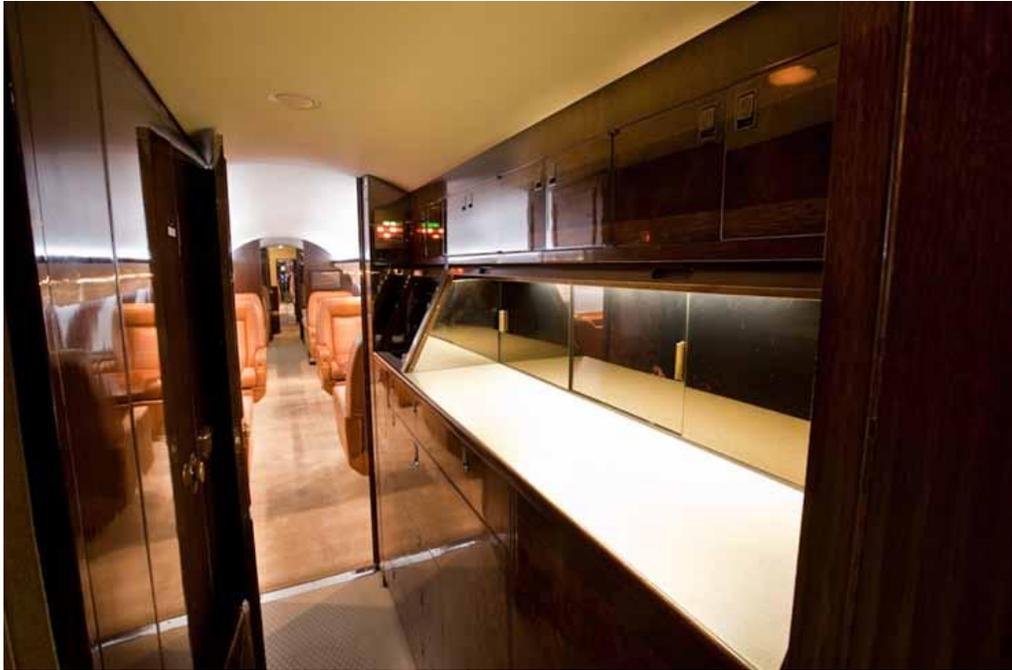
The leather seating was in excellent condition with no stains, tears, rips or loose stitching, with one exception located towards the bottom left side of the vertical cushion on the aft left-hand seat, which has a noticeable mark in the leather.

Where the furnishings have gold plating there is some wear evident in the areas receiving the most use, such as the seat belt hardware. Otherwise, the plating was very complimentary to the overall interior.

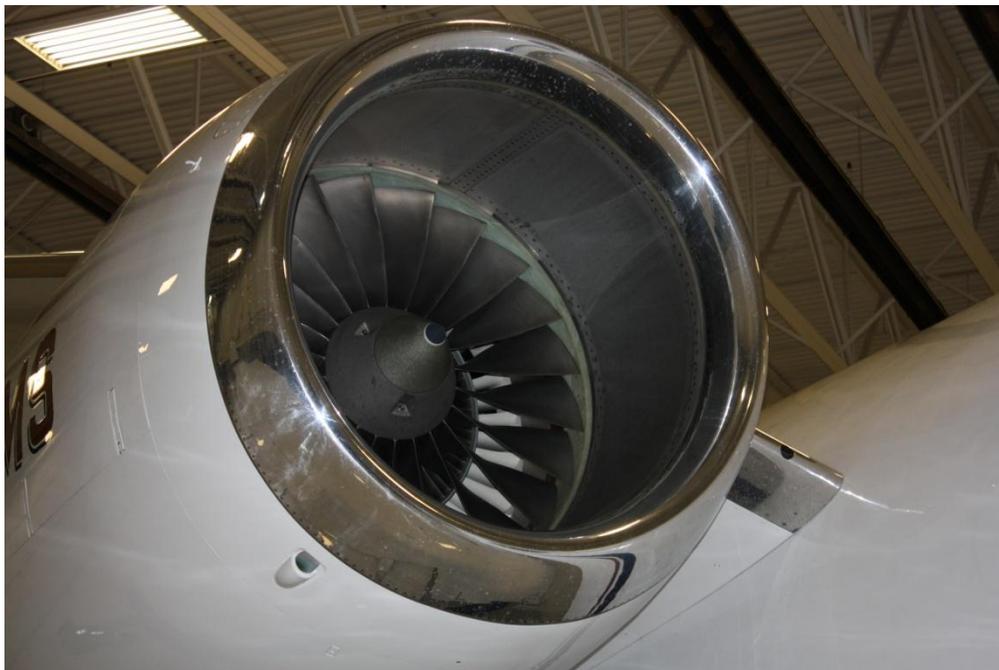
Engine Comments: The engines were overhauled by Dallas Airmotive, one of the more respected engine overhaul facilities.

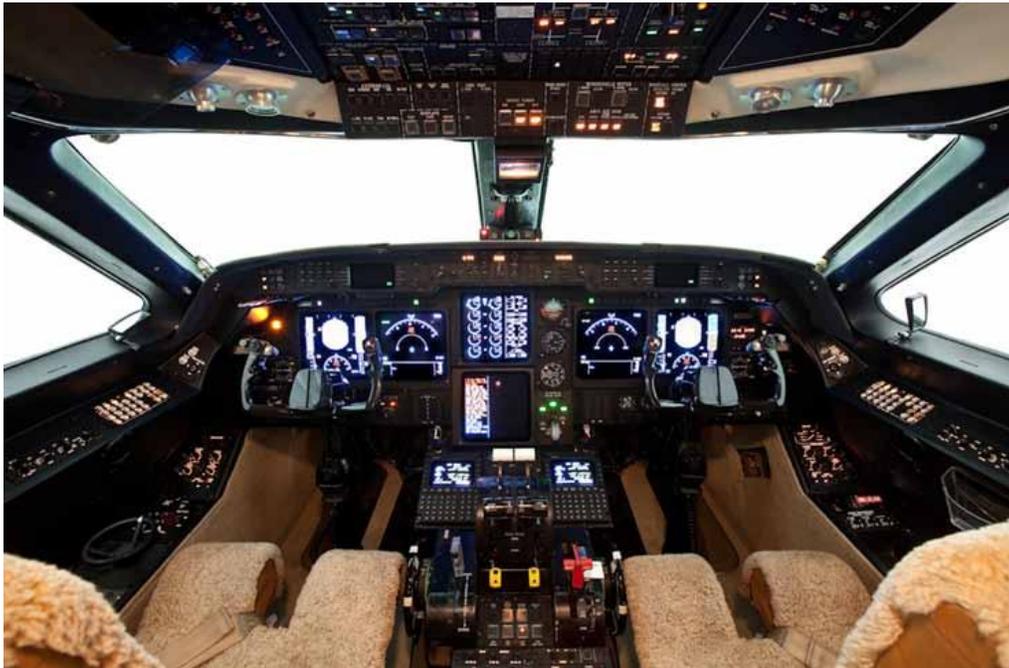
Comments: This aircraft suite of avionics is very well equipped, which is expected with this category, and manufacture of aircraft. The instrumentation did not have any visible signs of chips or cracked cases. The instrument markings that were available for me to see with limited power being applied were clearly visible and no cloudy, cracked, or distorted glass was evident. The pitot static system was last tested and certified 22 May 2013 and will be due again next 31 May 2015. The transponders were last checked and certified 21 May 2013 and will be due again next 31 May 2015. The aircraft is enrolled on the Honeywell HAPP avionics maintenance program.
